ITB08-045d

VOLUNTARY RECALL CAMPAIGN 2007 – 2008 PASSENGER AIR BAG OCCUPANT CLASSIFICATION SYSTEM (OCS)

CAMPAIGN ID #: P8243

APPLIED VEHICLES: 2007 – 2008 G35 Sedan (V36)
2008 G37 Coupe (CV36)
2008 EX35 (J50)

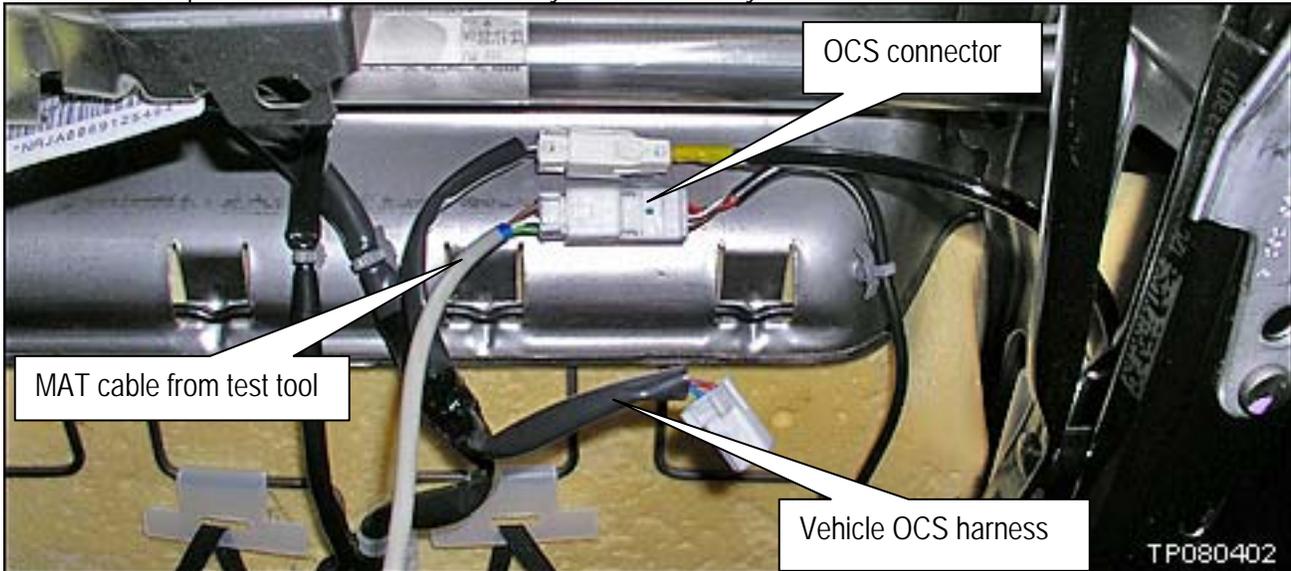
Figure 2

8. Look under the passenger seat; locate and disconnect the OCS connector and connect the MAT cable.

- The OCS connector is an 8 pin white connector (only 3 of the pins are used/filled).

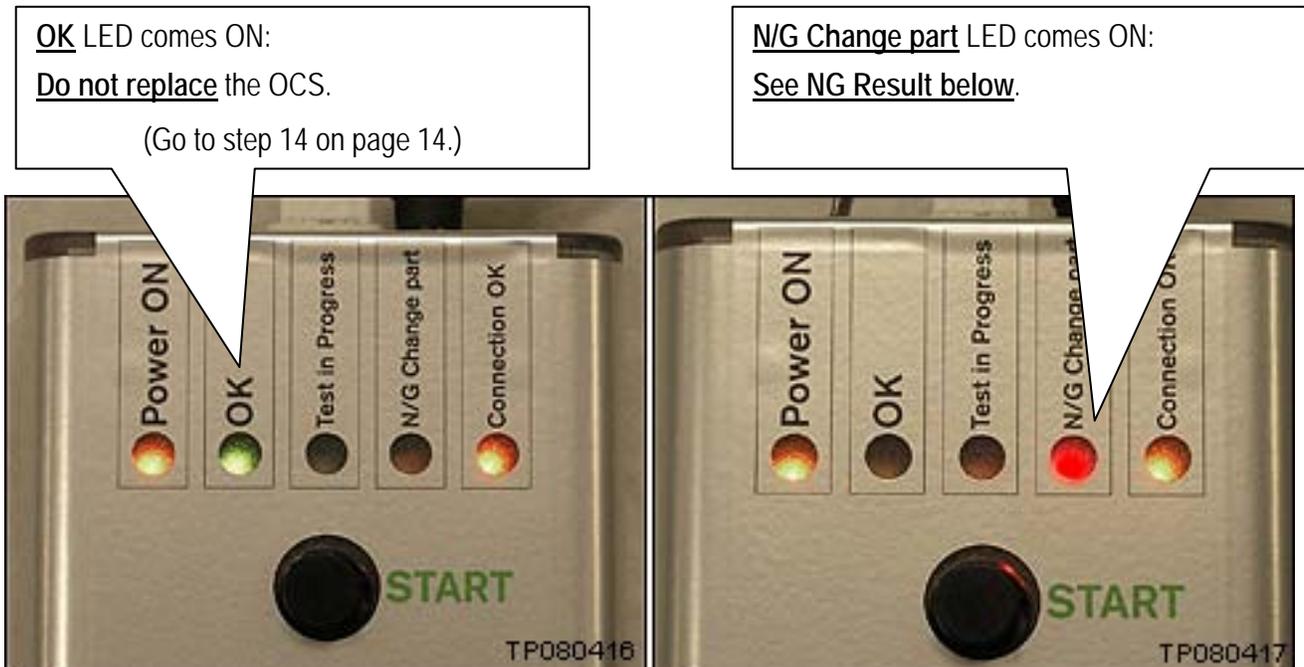
Figure 7

Actual inspection results:

NG results:

NG results are expected to be very low (less than 1% of vehicles tested).

If you get a NG result, do the following:

- a. Remove / disconnect both ends of the MAT cable that you are using.
- b. Get another serviceable new MAT cable and connect it to the Varistor Test Tool and the vehicle seat.
 - Make sure to mark the usage card for each MAT cable connection.
- c. Repeat the OCS inspection test (steps 9 though 13).
- d. After repeating the test with a second MAT cable (NG result 2 times), replace the OCS / seat cushion.
 - See OCS / seat cushion replacement on the next page.

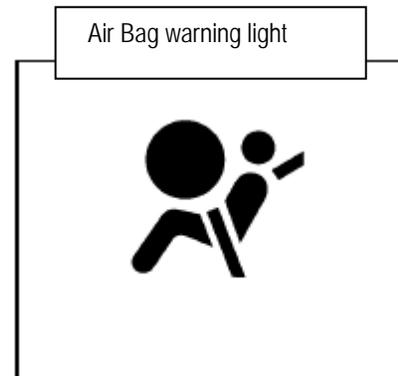
Figure 8

16. Check the Air Bag warning light and the Occupant Detection System warning light as follows:

- a. Sit in the driver seat and watch the warning lights as you turn the ignition ON.
- b. Both warning lights should turn ON for 5 – 7 seconds, and then go OFF.
- c. If either warning light does not turn ON at all, does not turn OFF, or blinks, refer to the Service Manual for diagnosis and repair.
