NUMBER 2 • NOVEMBER 2008

## CEREC 3D Onlay - Treating the Fractured Tooth Santine Anderson, D.D.S. Enspire Dental, Ann Arbor, MI, USA

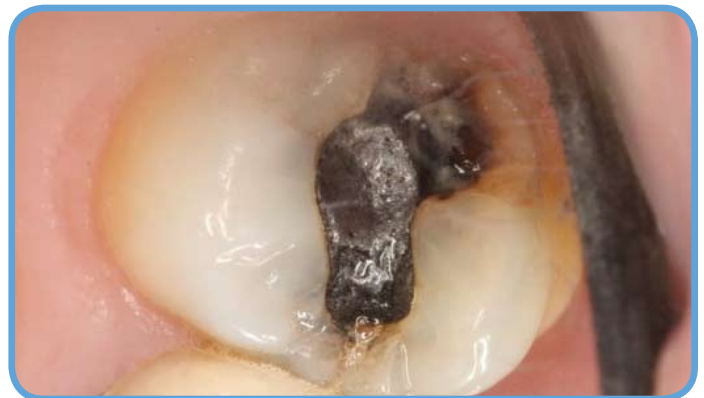
A clinical exam revealed a fractured distobuccal cusp and occlusal amalgam restoration on tooth #15. A radiograph revealed decay on the mesial of #15. There was no evidence of fracture in the remaining tooth structure or bruxism in the remaining dentition. A treatment plan for an MODB onlay was presented and accepted as a conservative, long-term treatment option.

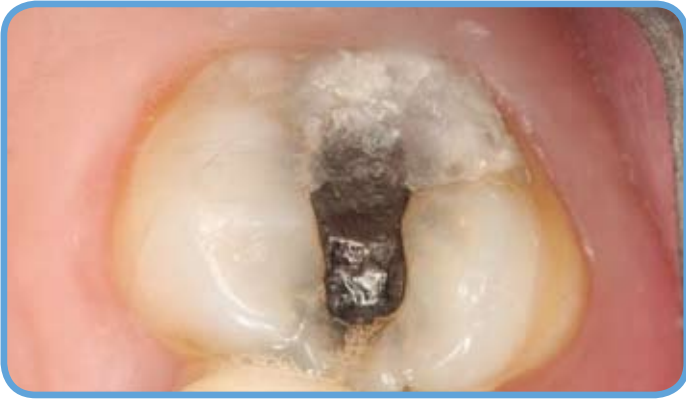
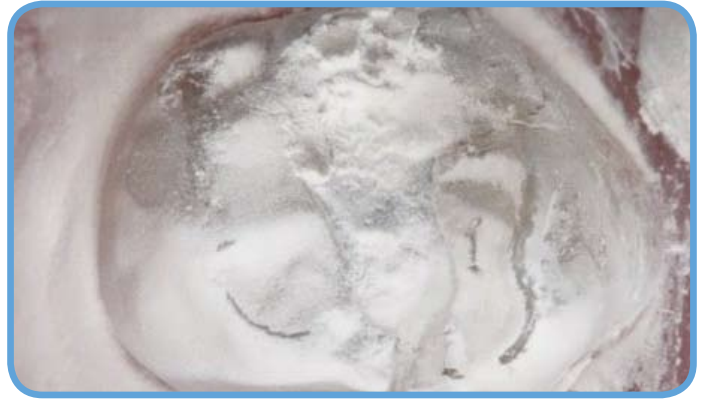
1. Anesthesia was administered and preoperative photos taken. A composite build-up of the missing tooth structure was placed and the occlusion adjusted.
2. Teeth #14 and #15, as well as a small amount of adjacent soft tissue, were powdered using the **Powder-Pro** (Advanced Dental Instruments, L.L.C). Three occlusal images were captured: one of #15, one slightly posterior to #15 and one of #14. **CEREC 3D** software provided an initial model of the teeth before preparation.

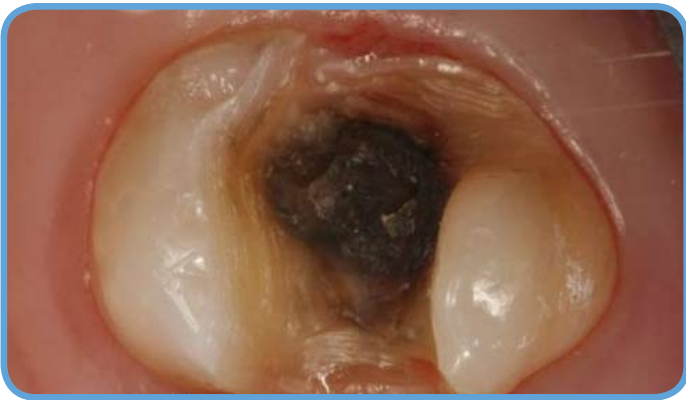
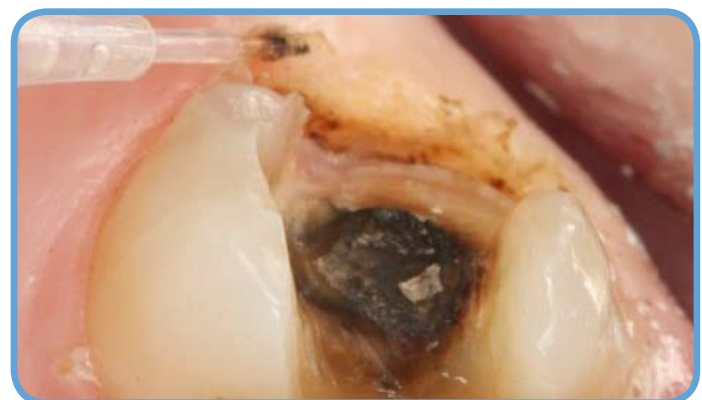
3. Once the patient achieved profound anesthesia treatment progressed rapidly. The amalgam and decay were removed, and an MODB preparation was completed. Careful consideration was given to ensure rounded internal angles and smooth walls to eliminate natural undercuts, minimize internal stresses and provide adequate reduction.
4. The **Odyssey 2.45 Diode Laser** (Ivoclar Vivadent) was used to recontour the tissue at the mesial & distal margins of the preparation. Due to the nature of the fracture and decay, these margins were subgingival. The laser conservatively and gently removed the inflamed tissue and allowed clear visualization of the margins. Complete tissue healing occurred in approximately three days.

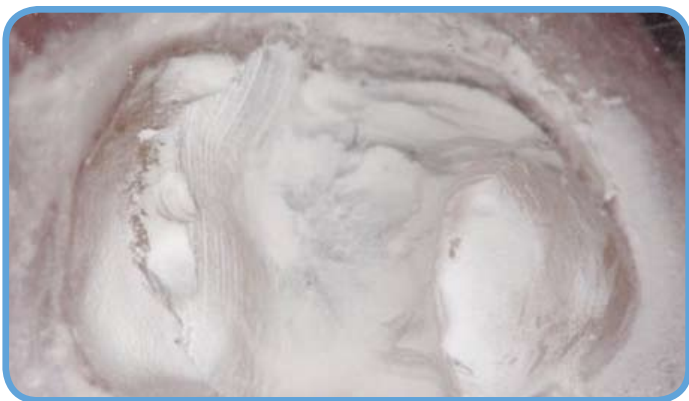
5. Teeth #14 and #15, as well as a small amount of adjacent soft tissue, were powdered using the **Powder-Pro**. Three occlusal images were captured: one of #15, one slightly posterior to #15 and one of #14. **CEREC 3D** software provided a model of the prepared tooth and the surrounding hard and soft structures.
6. Using the **CEREC 3D** software, the virtual die was trimmed, margins outlined and a final restoration configured using a database containing measurements of several thousand natural teeth. The mesial contact was adjusted and occlusal table reduced to reflect the height of the original tooth structure. The presence of adequate porcelain thickness was confirmed. A **CEREC Bloc 52-M** Size #10 was selected and the restoration was milled in less than ten minutes using the **MCXL**.

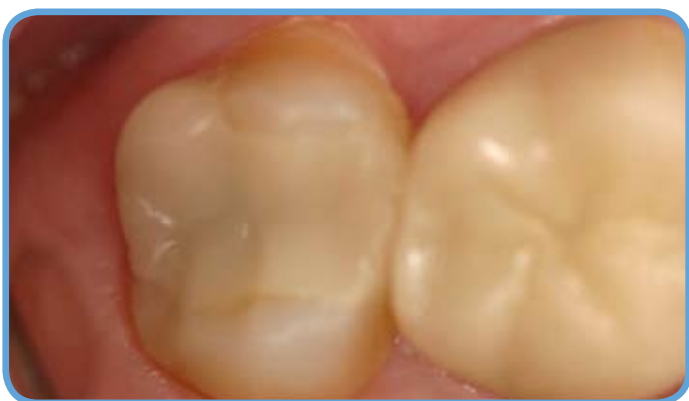
7. The sprue was removed from the distal surface of the restoration. The onlay was carefully placed on the tooth and the contact and margins checked. The restoration was etched using 9.6% hydrofluoric acid gel for five minutes and silanated using **Monobond-S** (Ivoclar Vivadent). The restoration was cemented using **MultiLink Primer A/B** and **MultiLink Automix** (Ivoclar Vivadent).
8. The occlusion was checked and adjusted as needed. The **NTI Ceraglaze System** (Axis Dental Corp.) was used to finish and polish the restoration.
