**CORROSION PERFORMANCE OF POLYMER-COATED,
METAL-CLAD AND OTHER REBARS AS
REINFORCEMENTS IN CONCRETE**

Research Report 4904-2

Research Project 7-4904

“Feasibility of Hot Dipped (Zinc) Galvanizing and Other Coatings for the Protection of
Reinforcing Steel”

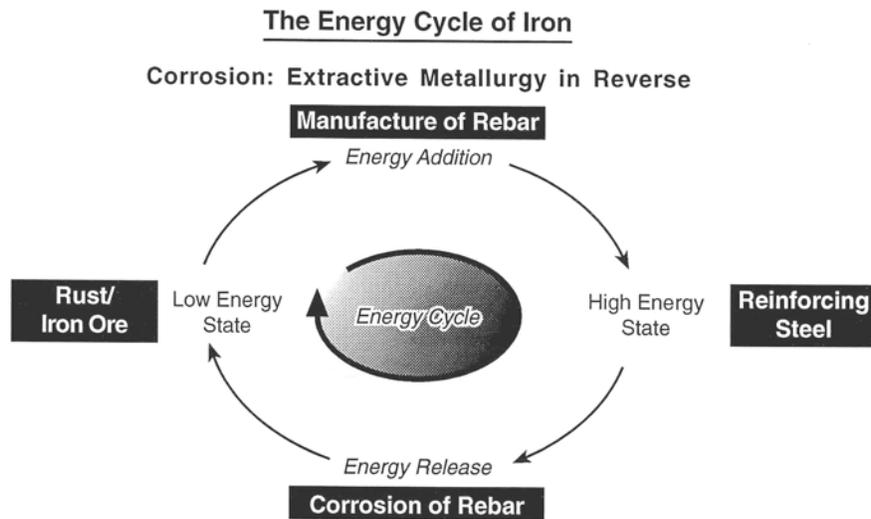
Figure 1.1: The Energy Cycle of Iron Indicating It Is Extractive Metallurgy in Reverse (Kahhaleh et al. 1994)

Corrosion of metals may be considered as extractive metallurgy in reverse (Fontana 1986). The process is described in Figure 1.1. Hence, the solution to corrosion problems may not always be in their total elimination (as this may be a difficult task). Rather, the answer may lie in a goal to find the most efficient way of living with them so as to cause minimal damage.

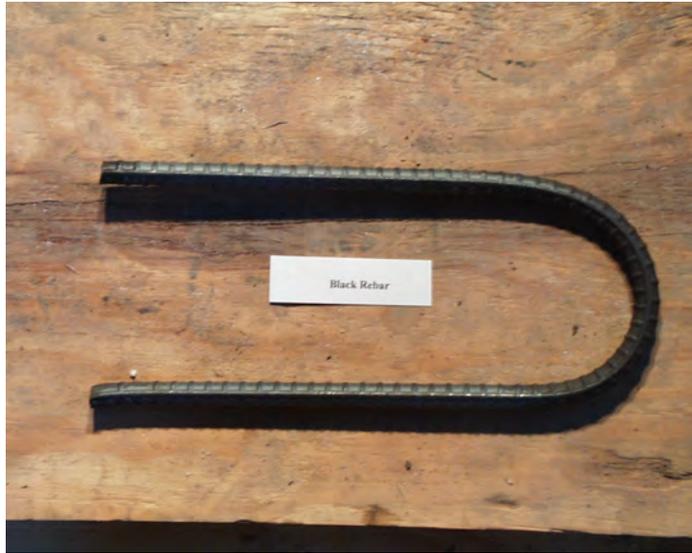
Figure 2.1: Black Steel Reinforcement Bar

Macrocell configurations for each of the corrosion resistant and control groups can be seen in Table 2.1. Photographs of various reinforcement bars used in this research project are shown in Figures 2.1 through 2.10.

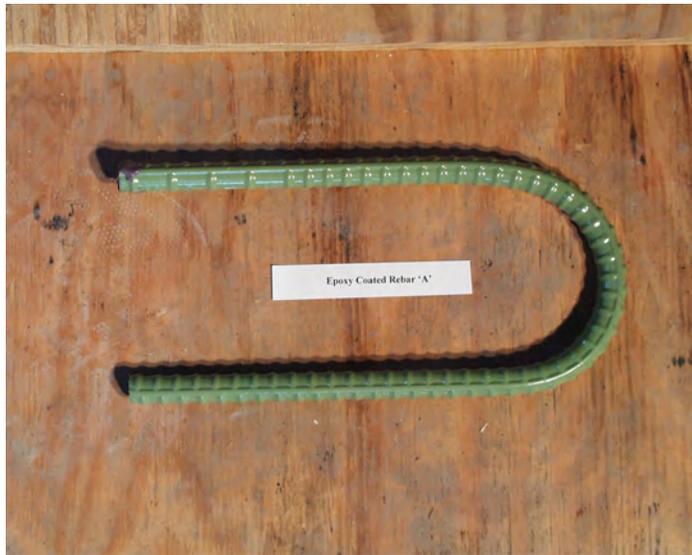
Figure 2.2: Epoxy-Coated Reinforcement Bar A

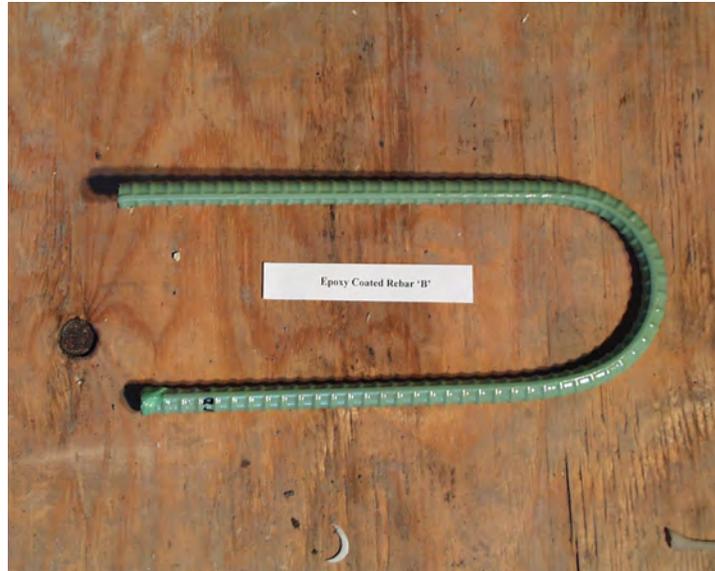
Figure 2.3: Epoxy-Coated Reinforcement Bar B

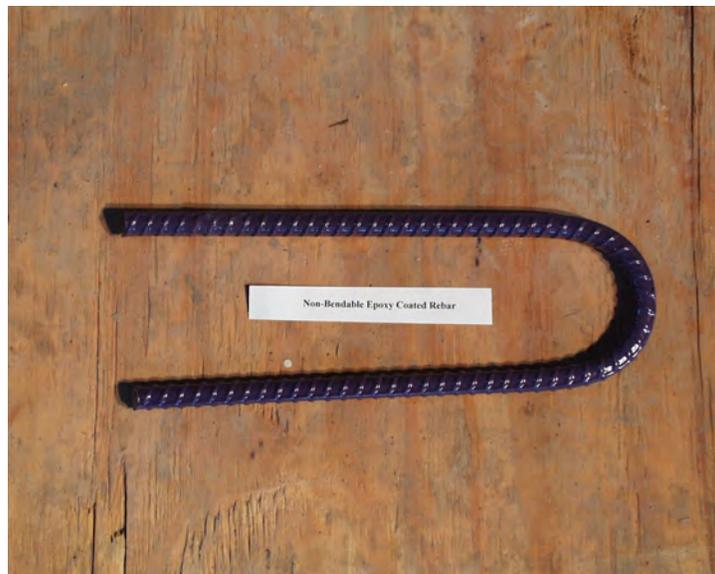
Figure 2.4: Nonbendable Epoxy-Coated Reinforcement Bar

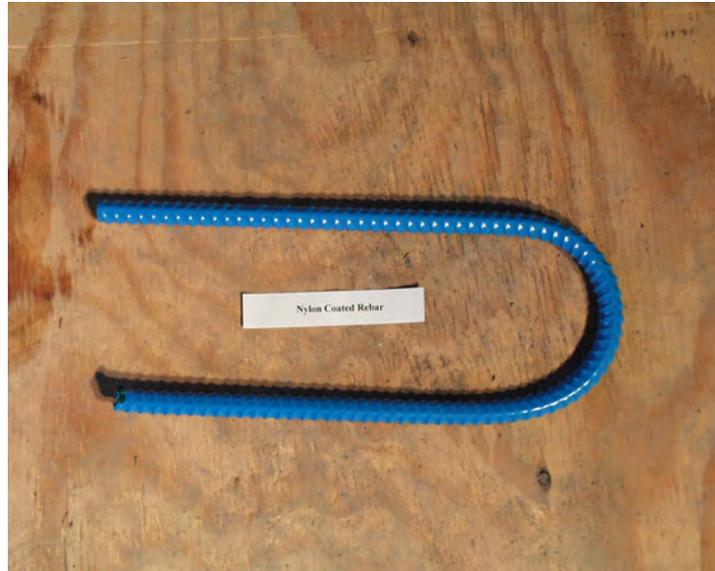
Figure 2.5: Nylon 11 Coated Reinforcement Bar

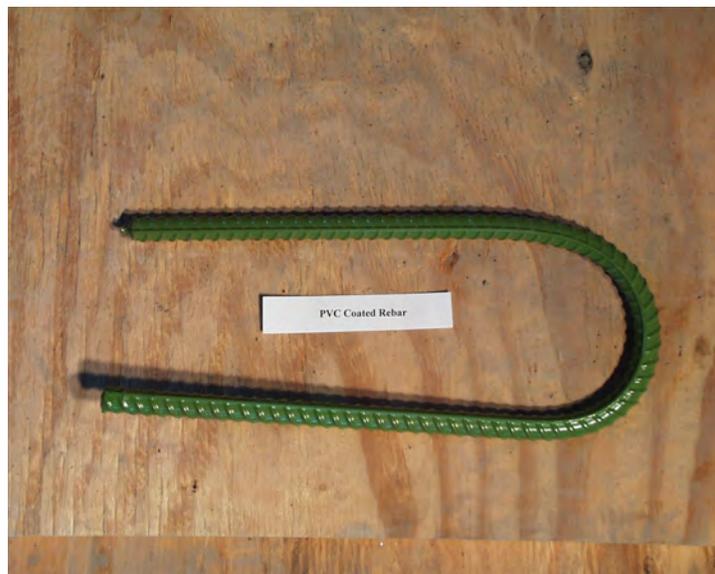
Figure 2.6: PVC-Coated Reinforcement Bar

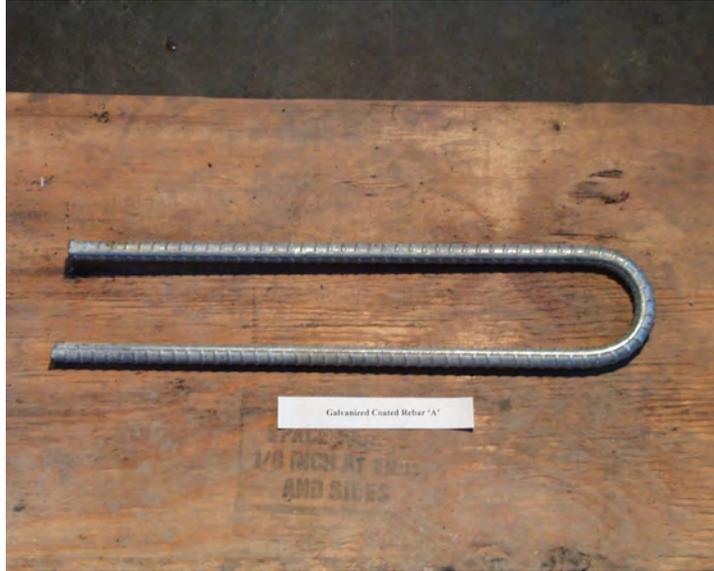
Figure 2.7: Galvanized-Coated Reinforcement Bar A

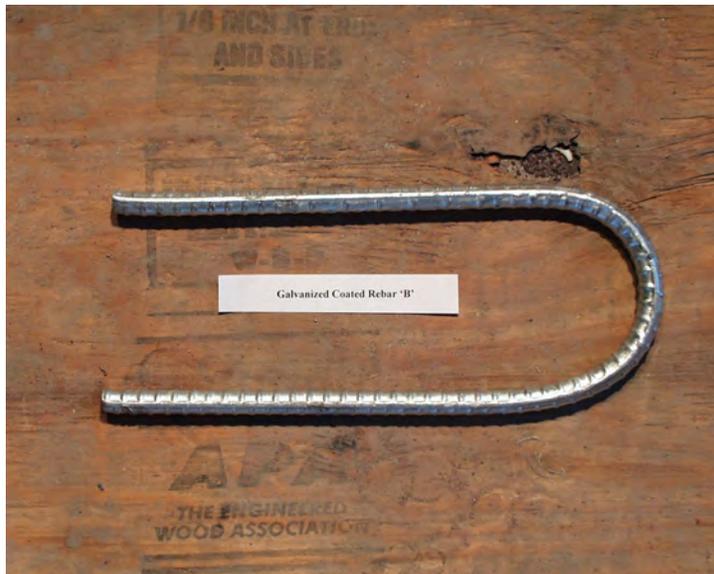
Figure 2.8: Galvanized-Coated Reinforcement Bar B

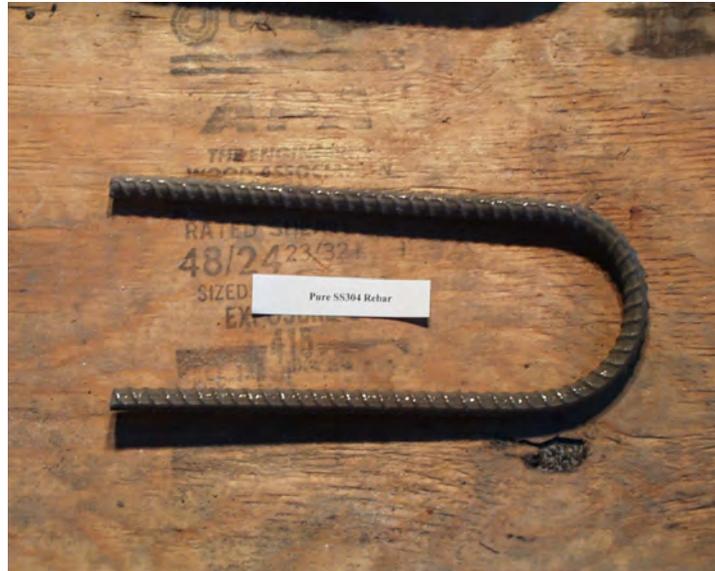
Figure 2.9: Pure Stainless Steel 304 Reinforcement Bar

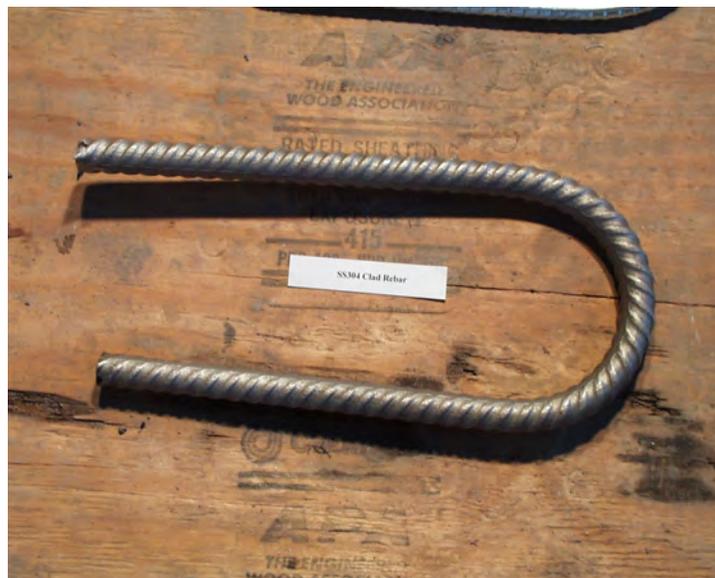
Figure 2.10: Stainless Steel 304 Clad Reinforcement Bar

The 304 stainless steel cladding was available only in a #6 bar size (3/4-inch diameter). Because of differences in the bar size, direct comparisons were not possible between the #6 stainless steel-clad bars and the #4 bars. Therefore, an additional control group and an additional epoxy-coated group were cast using #6 bars to eliminate bar size as a variable for evaluating the stainless steel-clad group.

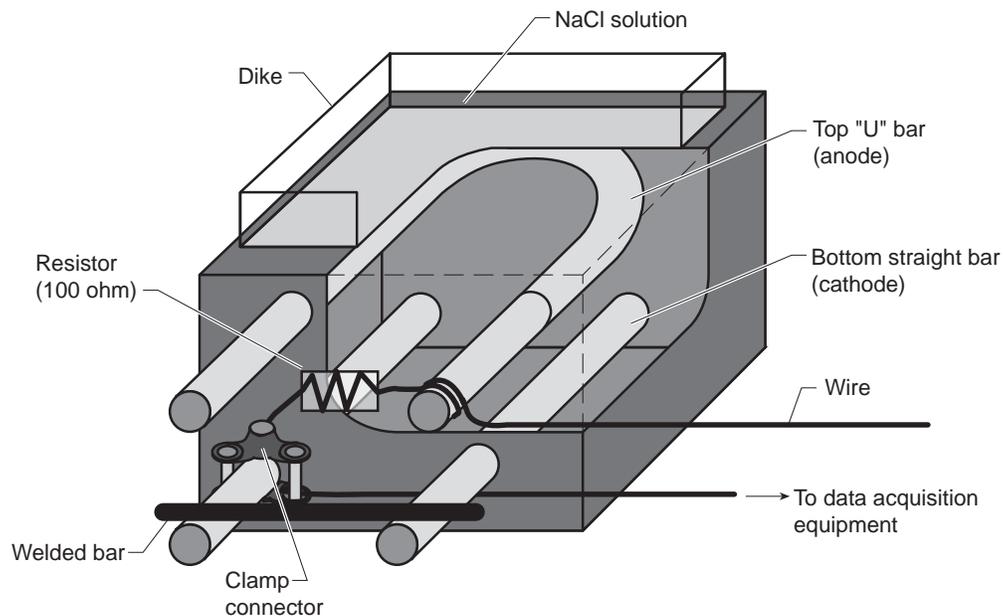
A schematic diagram of the macrocell specimen from Project 1265 can be seen in Figure 2.11. The overall dimensions of the macrocell used in this program were 10 inches long by 9 inches wide by 8 inches high. The macrocell consisted of two layers of steel bars embedded in a concrete prism. The top layer was a single bar that had been bent into a “U” shape. Both ends of the “U”-shaped bar protruded from the concrete prism. The bottom layer consisted of two straight bars. One end of each bottom straight bar protruded from the concrete prism.

Figure 2.11: Typical Project 1265 Macrocell Specimen

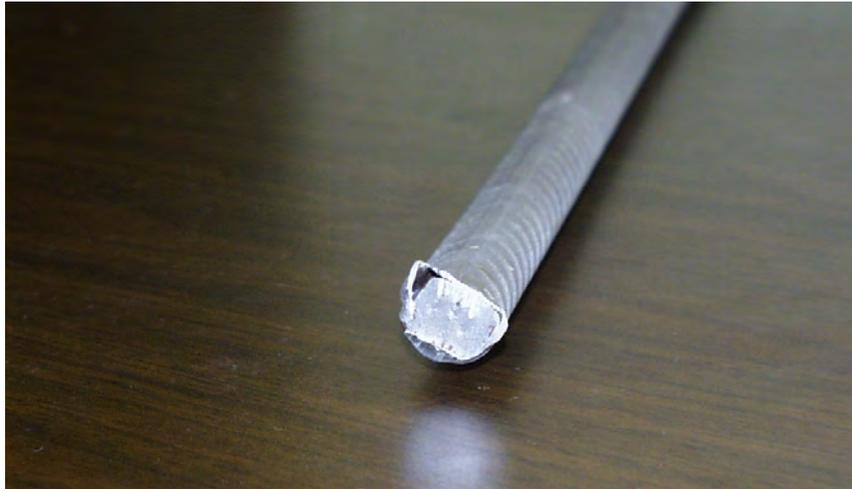
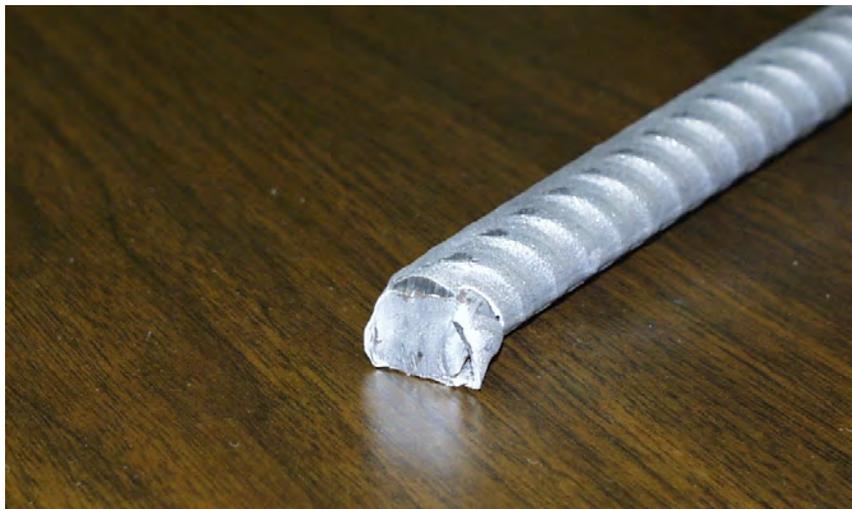
Figure 2.12: Separation of Stainless Steel Cladding from Shearing

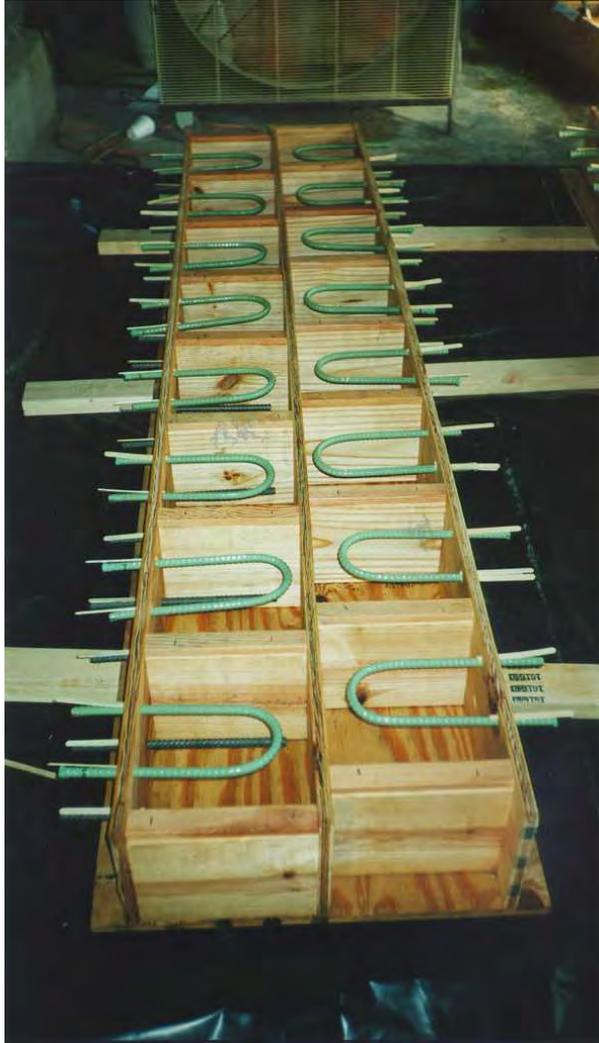
Figure 2.13: Typical Formwork for Macrocells with #4 Bars

The formwork for the #4 epoxy-coated bars and #6 304 stainless steel-clad bars is typical of the other sets of forms constructed and can be seen in Figures 2.13 and 2.14, respectively.

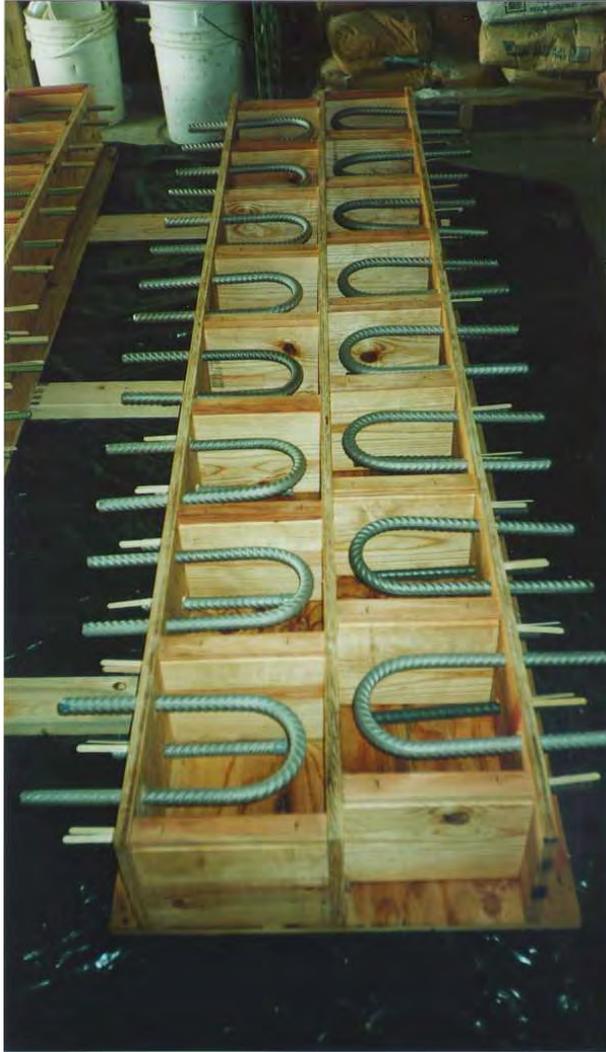
Figure 2.14: Typical Formwork for Macrocells with #6 Bars

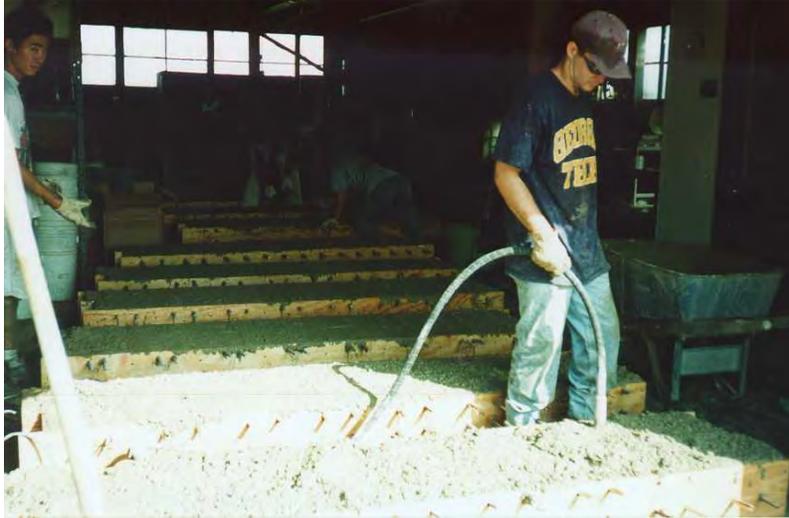
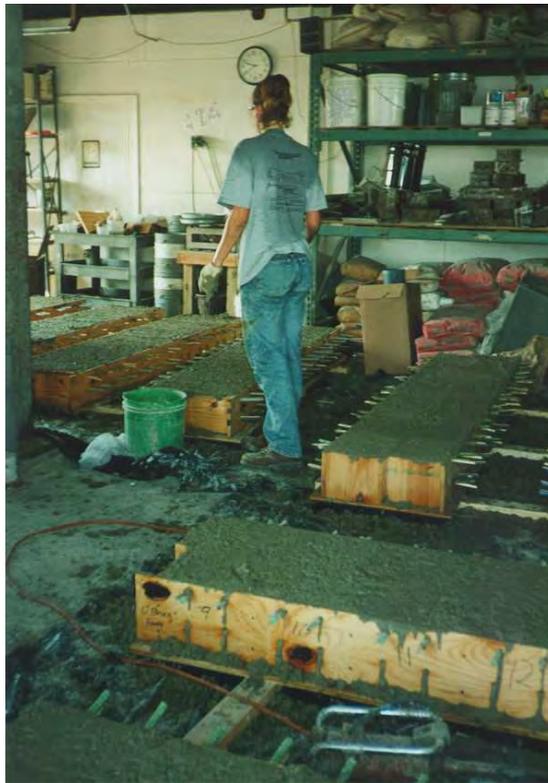
Figure 2.15: Macrocell Concrete Placement

It was observed that the method of securing the bars with wedges worked moderately well. The majority of the bars did not shift during casting. However, there were several instances when the vibrator head struck the bars, and the wedges did not prevent the bars from shifting.

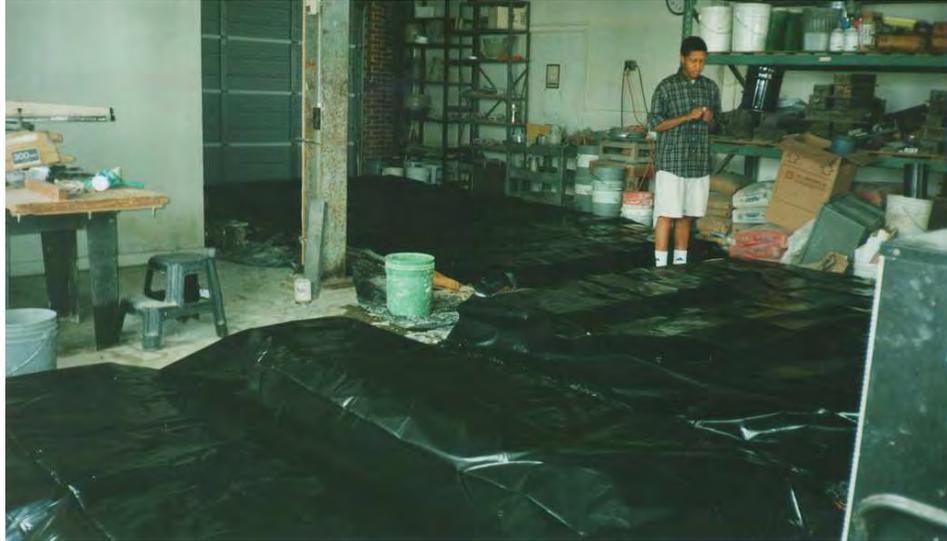
Figure 2.16: Curing of Macrocell Specimens

The top surfaces of the macrocells were trowel finished. After the initial set of the concrete, the formwork was covered with wetted curing blankets and plastic sheets to create a moist curing environment and to prevent shrinkage cracks. It is especially important to take proper curing precautions because cracking would likely affect the long-term, corrosion-monitoring results. Curing of the concrete is shown in Figure 2.16.

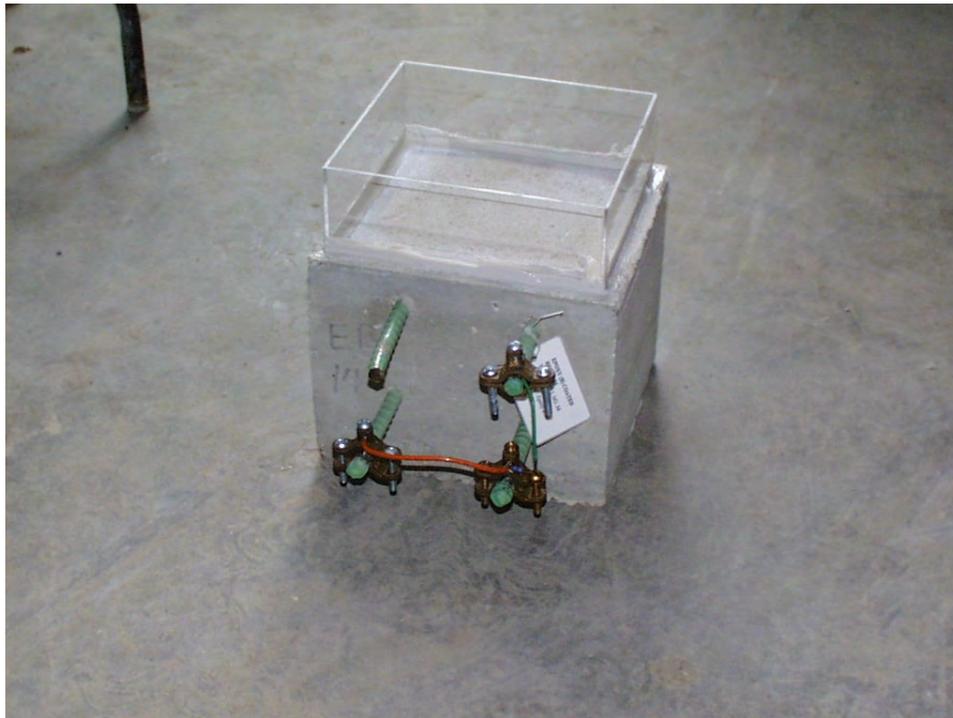
Figure 2.17: Completed Macrocell Specimen

In this project, metal clamps were attached to one end of the top bar and to each of the bottom bars. A 100 Ω resistor was soldered between the clamp on the top bar and one of the clamps on the bottom bars. The bottom bars were connected by a copper wire that was soldered at each end to the clamps. The wiring configuration can be seen in Figure 2.17.

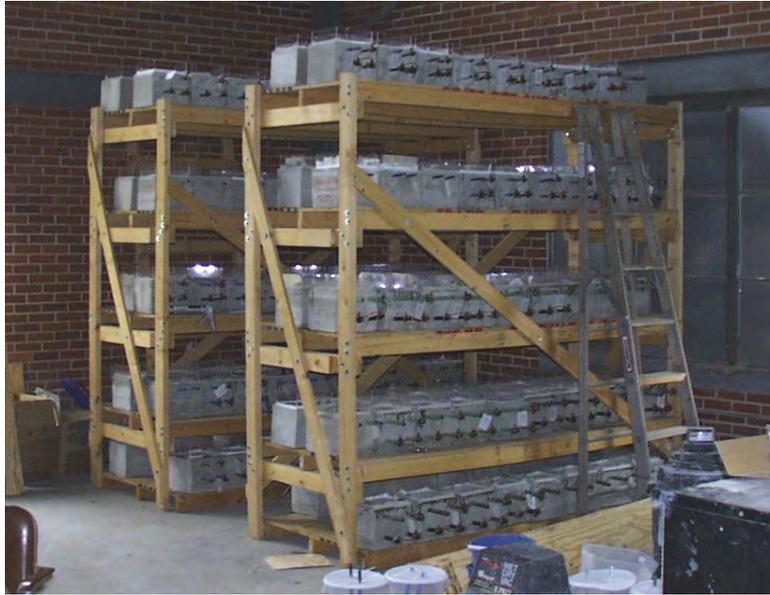
Figure 2.18: Macrocell Storage Racks

protected from wind and rain, but the room did not have any climate control equipment. The storage racks containing the macrocells can be seen in Figure 2.18.

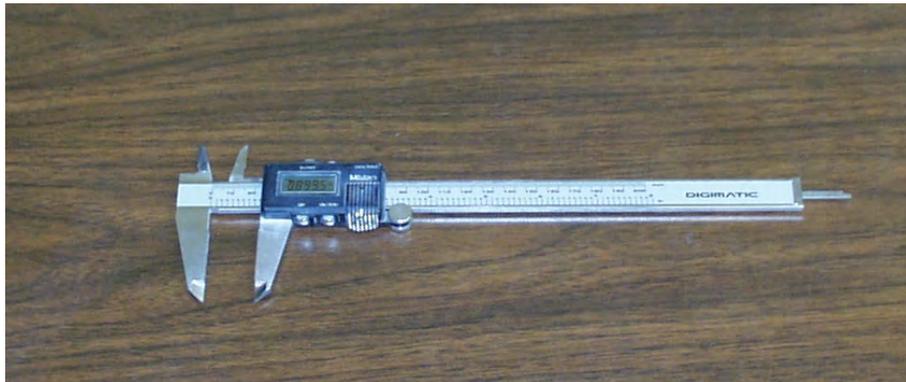
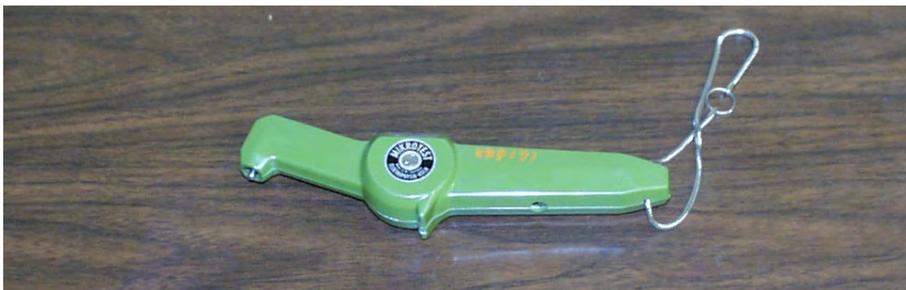
Figure 2.19: Digital Calipers and Coating Thickness Gage

Measurements of the bar deformation and coating properties were taken from a random sampling of bars when received from the manufacturer. The bar deformation properties were recorded using Mitutoyo Digimatic digital calipers, and the coating thickness was measured using a Mikrotest thickness gage (Figure 2.19). The measurements are listed in Table 2.3 and include the average deformation spacing, average deformation height, average gap between deformations, and average coating thickness. The weight of the bar was not measured because an accurate correction for the weight of the coating was not possible.

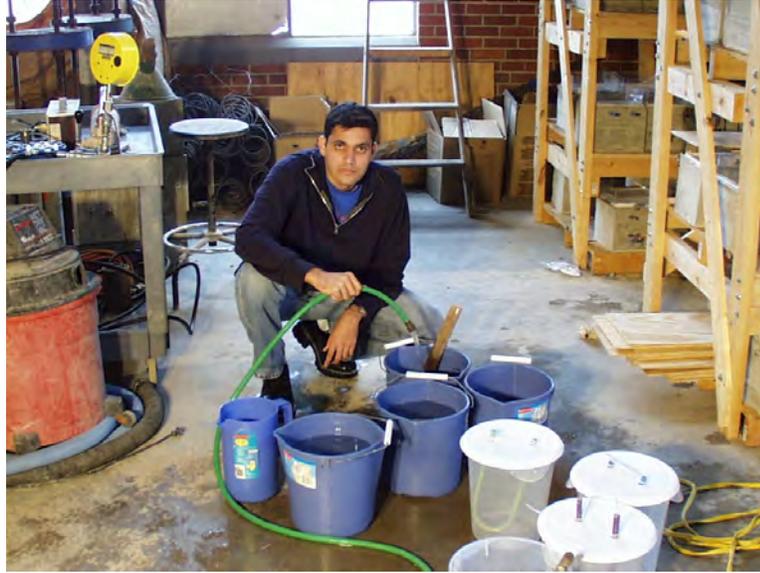
Figure 2.20: Researcher Making 3.5% NaCl Solution at the Beginning of the “Wetting Cycle”

The long-term exposure to chlorides began after the macrocells were completed and placed on the storage racks. To expose the concrete to chlorides, a saltwater solution with 3.5% NaCl was ponded in the reservoir on the macrocell. The ponding will occur over a 4-week cycle on a 2-week wet/2-week dry basis. The reservoirs are covered with plywood after the saltwater solution is added to limit the amount of evaporation. Pictures of the saltwater preparation and ponding can be seen in Figures 2.20 – 2.22.

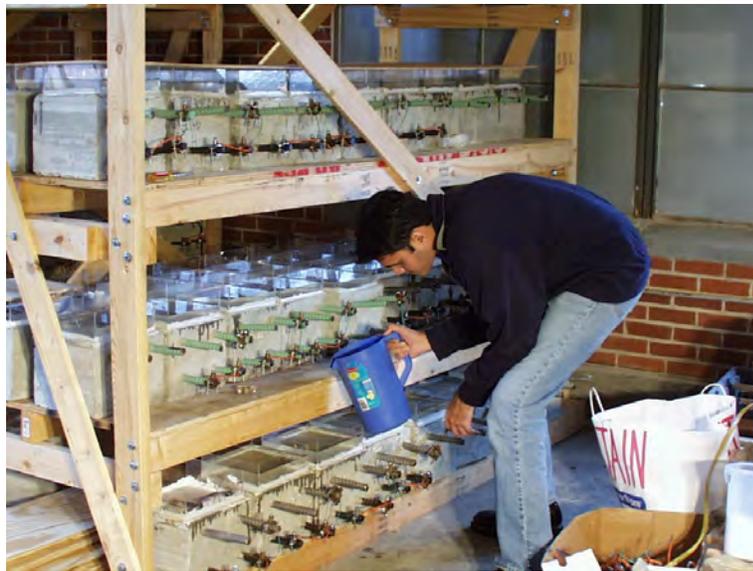
Figure 2.21: Researcher Pouring 3.5% NaCl Solution in Dikes at Beginning of “Wetting Cycle”

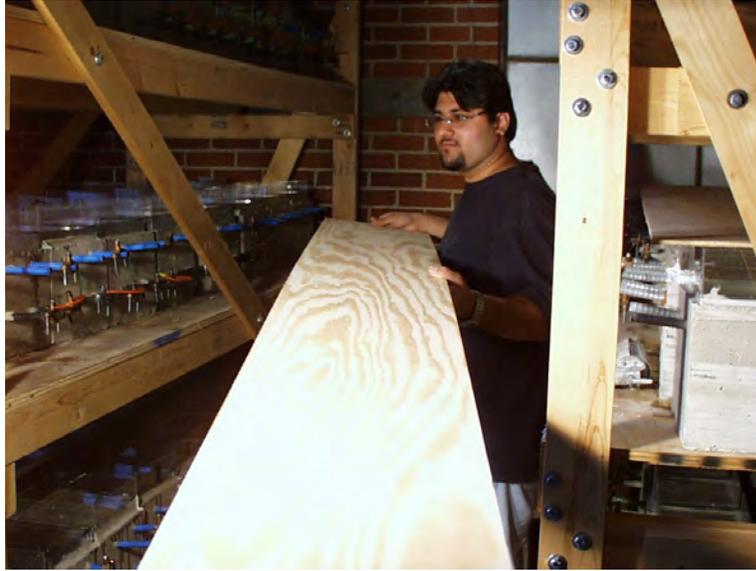
Figure 2.22: Student Placing Plywood Sheet over Macrocell-Filled Dikes to Minimize Evaporation

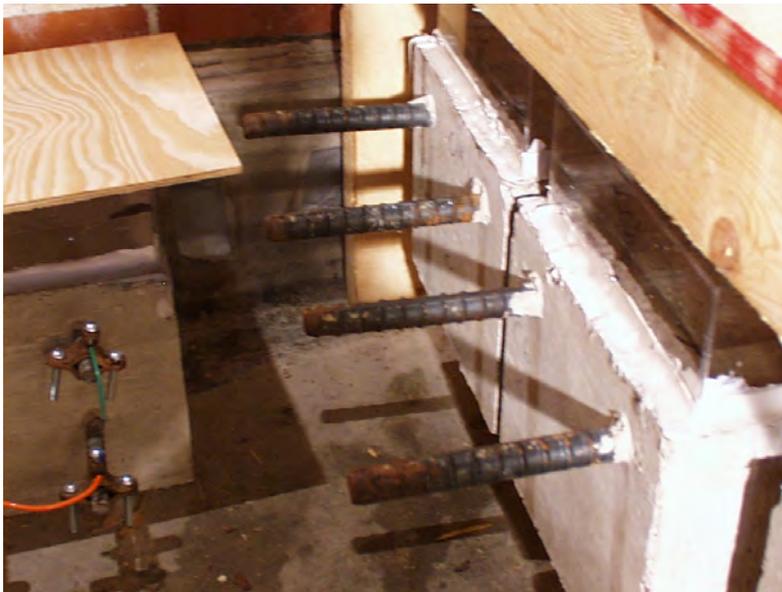
Figure 2.23: Macrocells with One Bent Black Rebar as Top-Reinforcing Layer and None in the Bottom-Reinforcing Layer

A close-up view of macrocells with top bars only and bottom bars only can be seen in Figures 2.23 and 2.24.

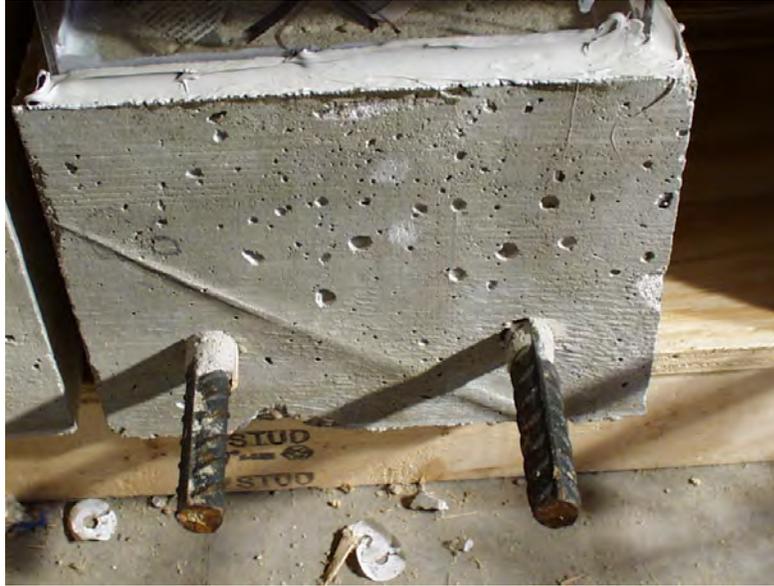
Figure 2.24: Macrocells with Two Straight Black Rebars as Bottom-Reinforcing Layer and None in the Top-Reinforcing Layer

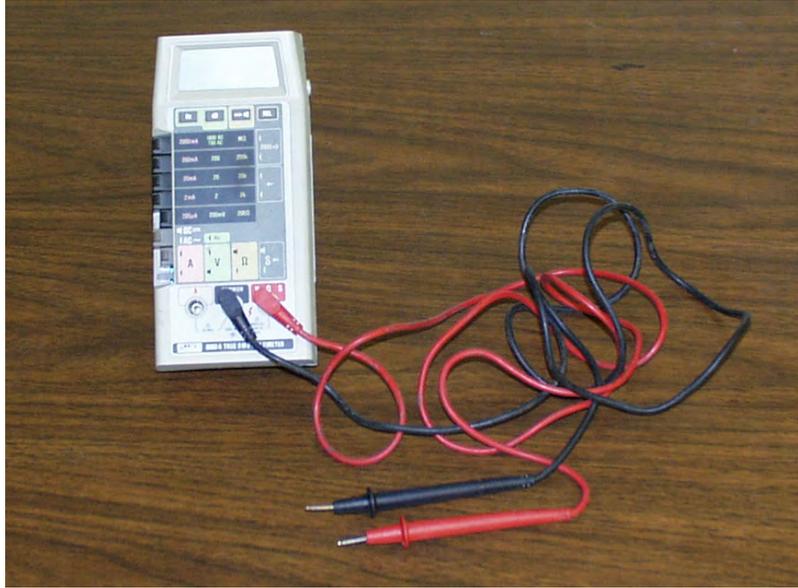
Figure 2.25: Multimeter

As stated above, current flow can be used to monitor the amount of corrosion in the macrocell. Corrosion readings were taken weekly. The voltage was measured across the 100Ω resistor with the Fluke 8060A True RMS Multimeter shown in Figure 2.25. The current was calculated from the potential using the equation $I = V/R$, where I is the electrical current, V is the measured electrical potential, and R is the resistor rating (100Ω). Also, the condition of the concrete was monitored visually for signs of staining and cracking.

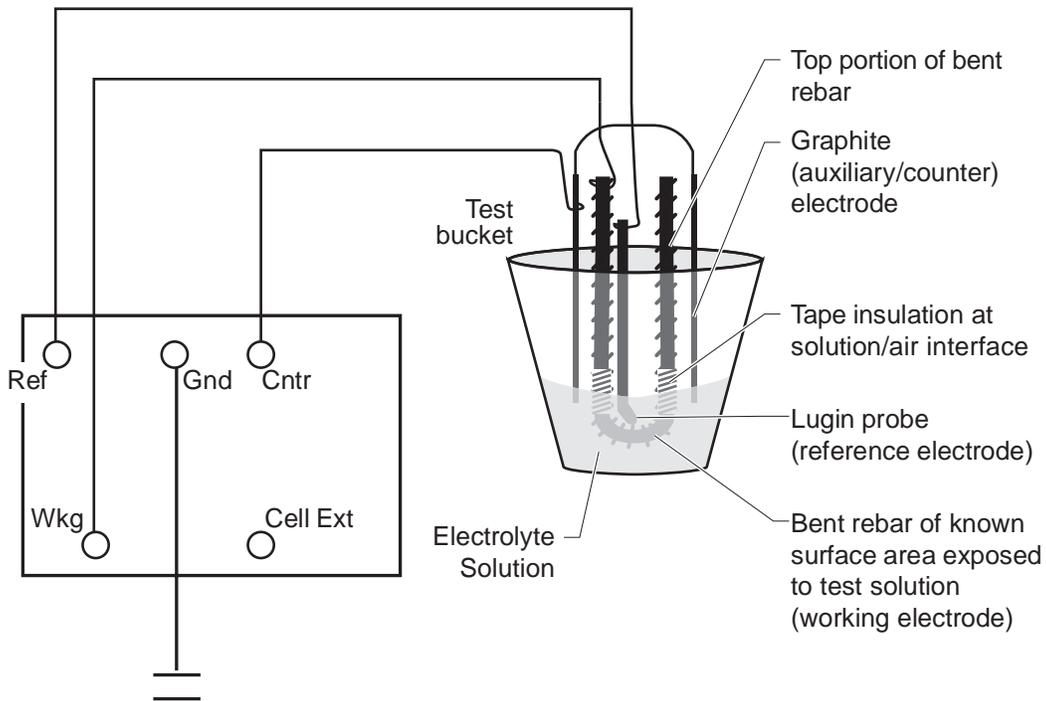
Figure 3.1: Schematic Diagram of Polarization Resistance Test Cell

However, in this project, the specimens or the working electrodes were bent #4 or #6 bars; hence, considerable changes had to be made to the test cell to fit the large working electrode. See Figure 3.1 for details.

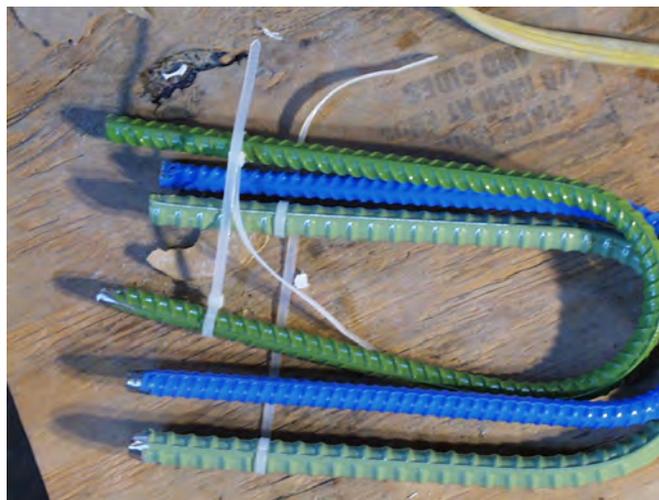
Figure 3.2: Polymer-Coated Rebars with Their Tips Polished to Ensure Good Electrical Contact during Polarization Resistance Test

- A particular rebar specimen was selected to be the working electrode.
- The tip of the working electrode was ground off, if it was a coated rebar, to facilitate proper electrical connections.
- The tip was polished as shown in Figure 3.2.
- The working area (the portion of the rebar to be exposed to the electrolyte) of the rebar was cleaned and degreased.
- The surface area of the rebar portion to be exposed was measured (in square cm).

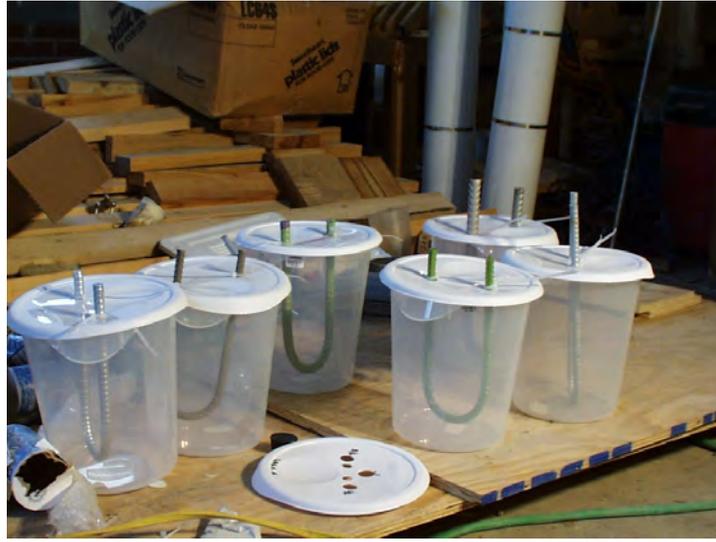
Figure 3.3: Polarization Resistance Test Cells without Connections

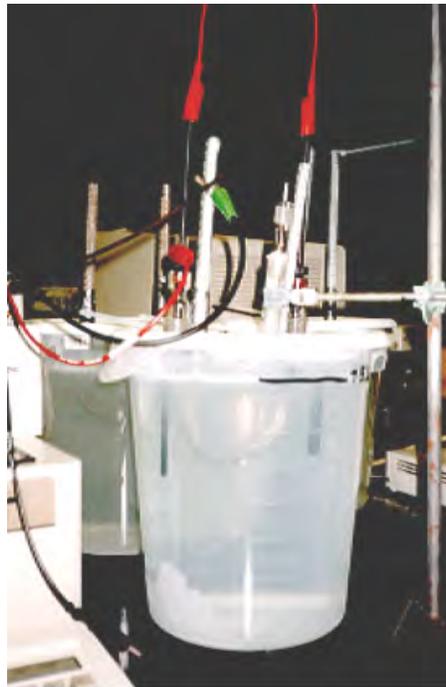
Figure 3.4: Polarization Resistance Test Cells with Connections

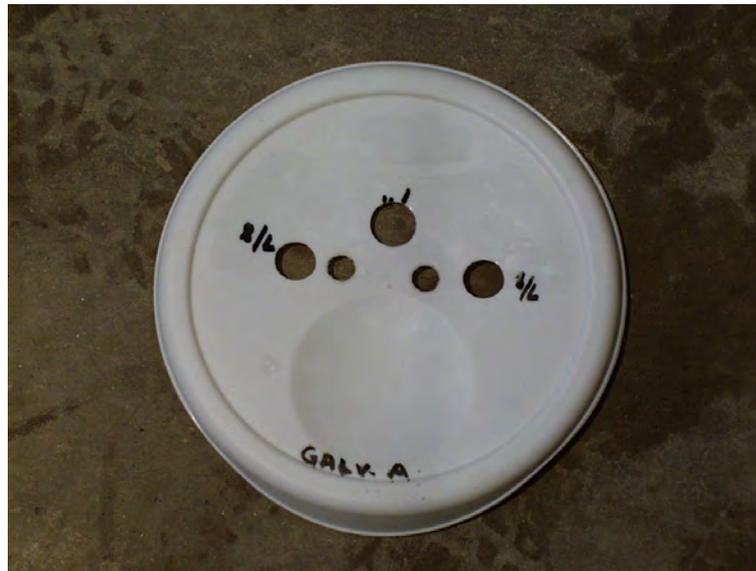
Figure 3.5: Lid of Polarization Resistance Test Cell with Holes to Accommodate the Rebar, the Reference Electrode and the Lugin Probe

- The level of the solution was to cover the bend and adjacent areas, and the remaining portion of the rebar was insulated with tape to avoid its contact with the electrolyte. Also, epoxy adhesive was placed on the tape to minimize crevice corrosion.
- Holes of appropriate diameter were drilled in the lid of the test cell as shown in Figure 3.5.

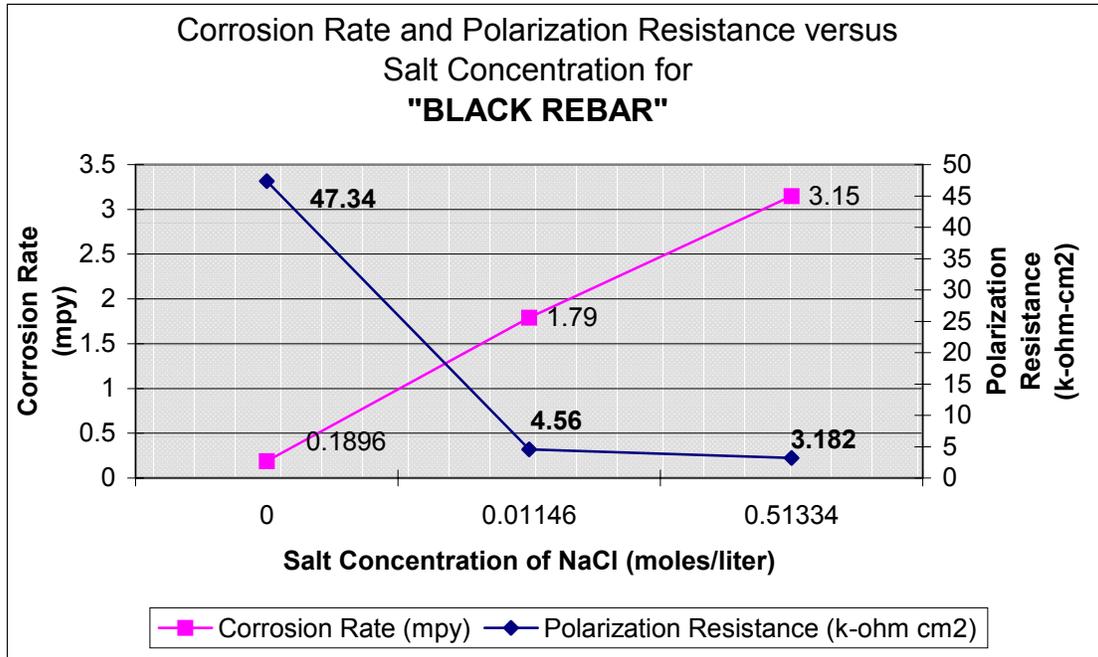
Figure 3.6: Corr. Rate and PR versus Salt Concentration for Black Steel

The corrosion rate increased steadily with increasing chloride concentration (as shown in Table 3.3 and Figure 3.6). The corrosion rate of black steel in calcium hydroxide solution contaminated with 3.5% NaCl was 1.75 times the corrosion rate in calcium hydroxide contaminated with the threshold amount of NaCl (Figure 3.6).

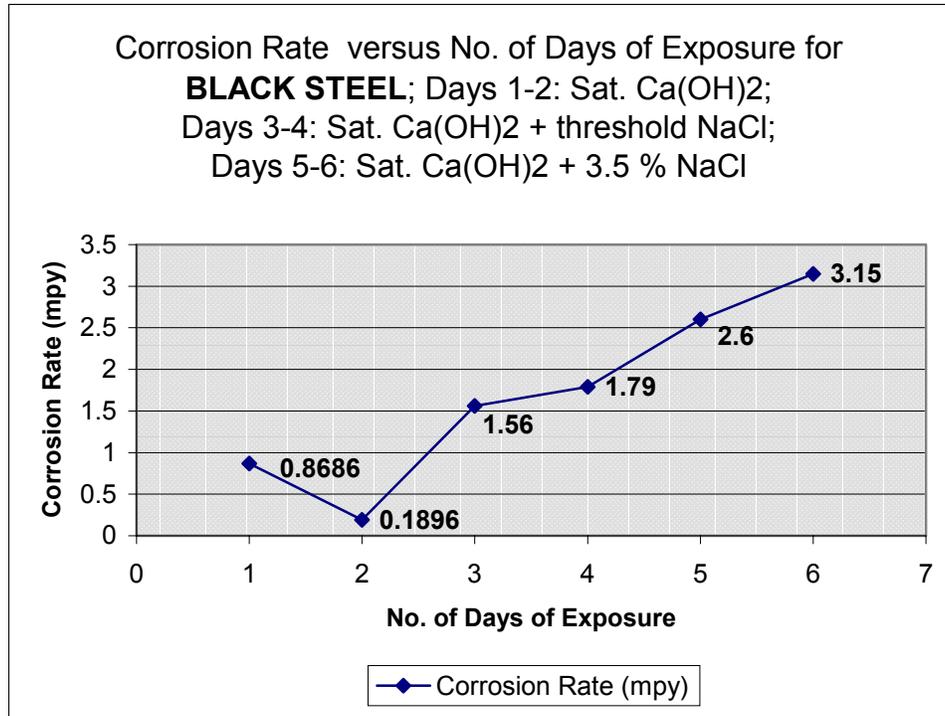
Figure 3.7: Corr. Rate versus No. of Days for Black Steel

There was an initial drop in the corrosion rate during the 2-day exposure to calcium hydroxide solution (Figure 3.7), which may be due to the formation of a passivation layer. However, the corrosion rate once again increased on addition of increasing amounts of NaCl, indicating possible damage to the protective passivation layer.

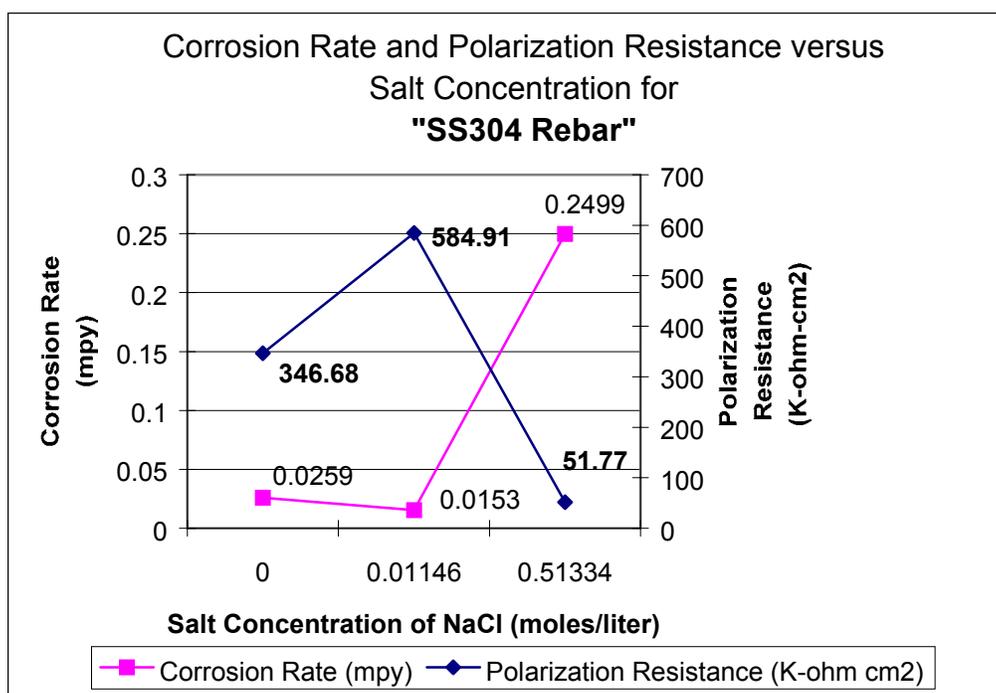
Figure 3.8: Corr. Rate and PR versus Salt Concentration for SS304 Rebar

As expected, the pure stainless steel 304 rebar performed exceedingly well compared to the black steel. There was a twelve-fold decrease in PR value on increasing the chloride concentration from the threshold amount to 3.5%. Therefore, the corrosion rate value increased drastically with the increase in chloride concentration from the threshold amount to 3.5% NaCl. This showed significant dependence of the corrosion rate of SS304 on the concentration of chloride ions. However, the maximum corrosion rate was still low (0.2499 mpy) when compared to black steel.

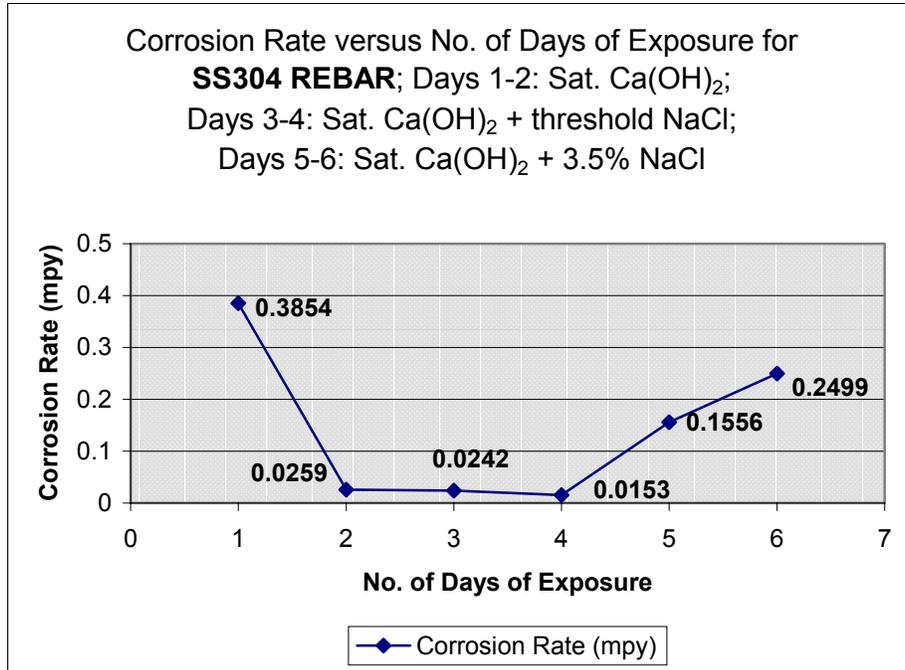
There was an initial drop in the corrosion rate after 1 day of exposure to calcium hydroxide solution, again indicating possible formation of a passive oxide layer (Figure 3.9). This layer was perhaps damaged on addition of chloride concentration greater than the threshold amount.

Figure 3.9: Corr. Rate versus No. of Days for SS304 Rebar

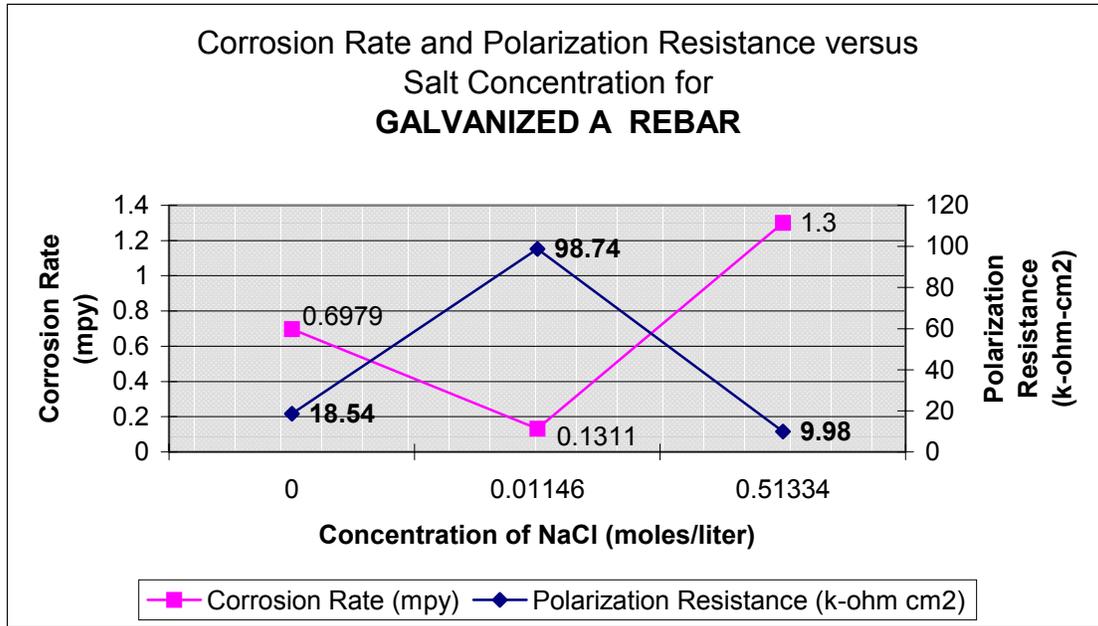
Figure 3.10: Corr. Rate and PR versus Salt Concentration for Galvanized A Rebar

It is evident that the corrosion rate dropped initially from 0.69 to 0.13 mpy on addition of the threshold amount of NaCl (Figure 3.10). However, it stabilized at a rate of 1.3 mpy after addition of 3.5% NaCl to the calcium hydroxide solution.

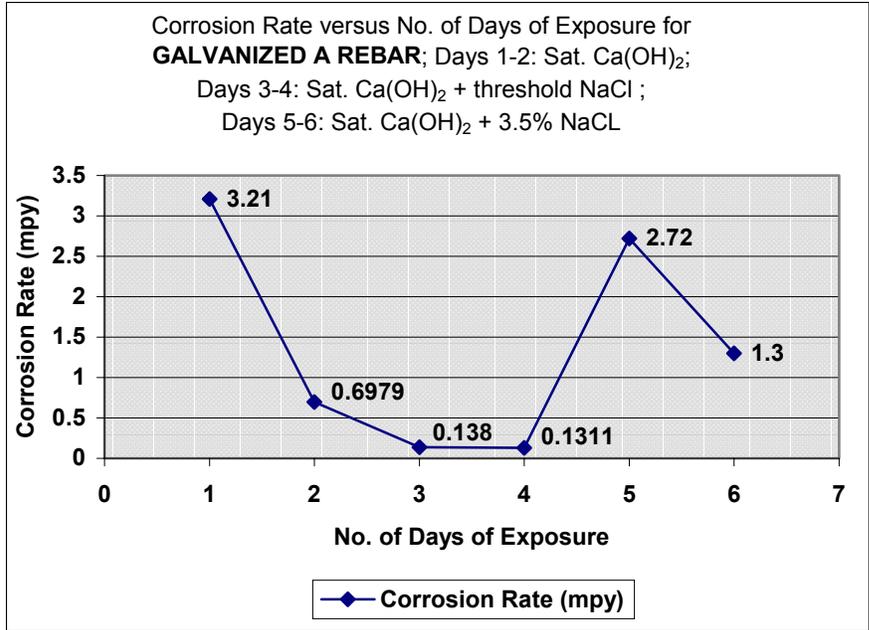
Figure 3.11: Corr. Rate versus No. of Days for Galvanized A Rebar

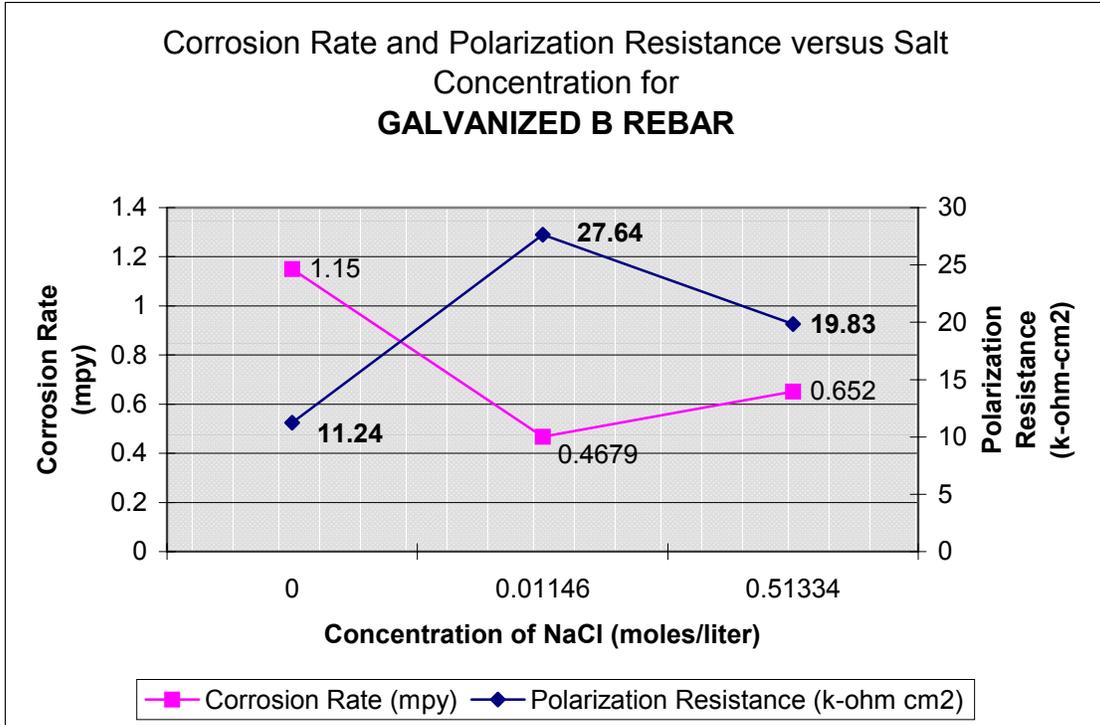
Figure 3.12: Corr. Rate and PR versus Salt Concentration for Galvanized B Rebar

Once again, it is evident that the corrosion rate dropped initially from 1.15 to 0.46 mpy on addition of the threshold amount of NaCl (Figure 3.12). However, it increased to 0.652 mpy on addition of 3.5% NaCl to calcium hydroxide solution.
