**CORROSION PERFORMANCE OF POLYMER-COATED,
METAL-CLAD AND OTHER REBARS AS
REINFORCEMENTS IN CONCRETE**

Research Report 4904-2

Research Project 7-4904

“Feasibility of Hot Dipped (Zinc) Galvanizing and Other Coatings for the Protection of
Reinforcing Steel”

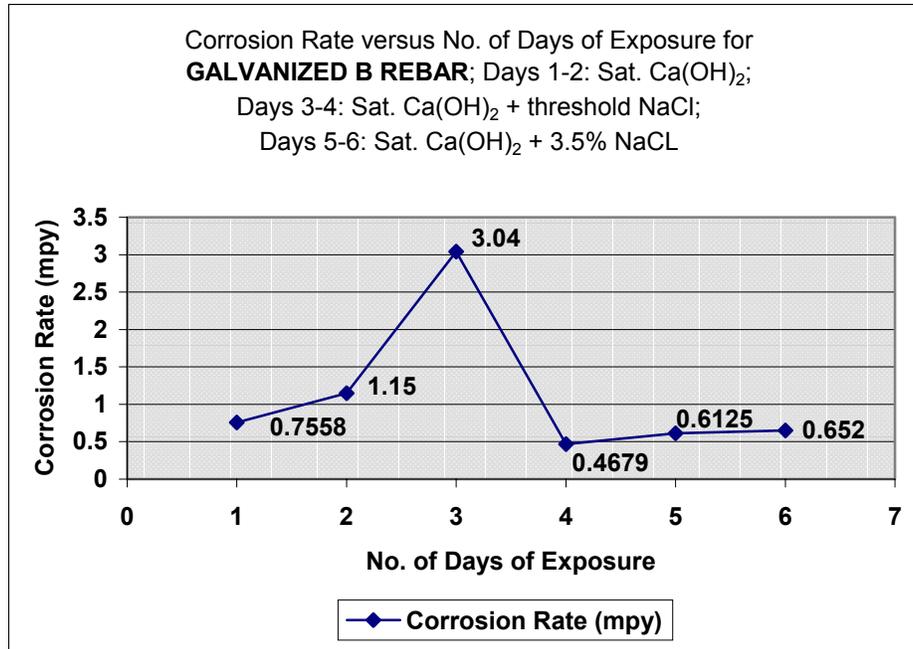
Figure 3.13: Corr. Rate versus No. of Days for Galvanized B Rebar

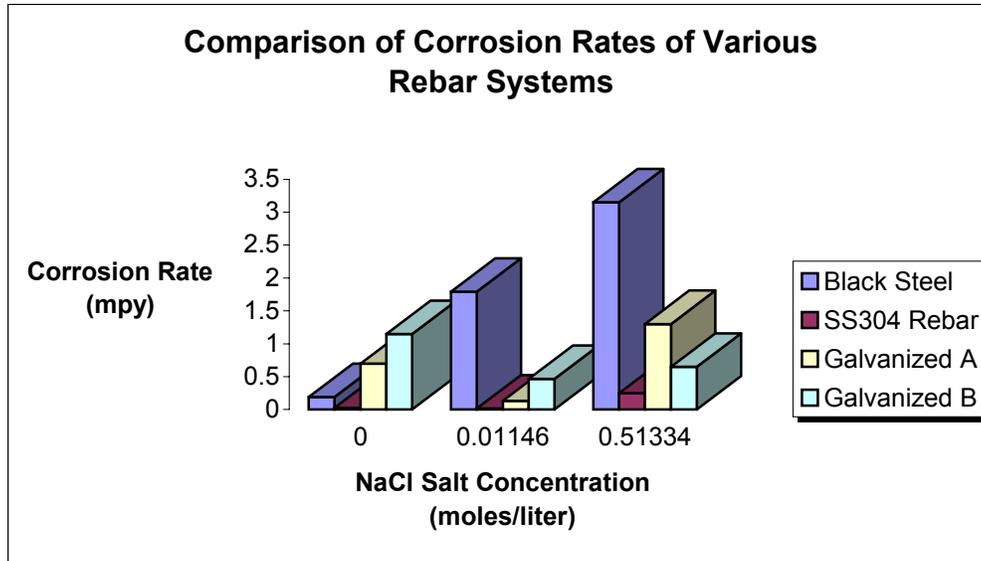
Figure 3.14: Comparison of Corrosion Rates of Various Rebars

It is evident that SS304 rebar performed quite well (Figure 3.14) in all three solutions. It had extremely low corrosion rates and should be an excellent material in the form of a pure rebar or a clad bar (which would be more economical). Black steel, as expected, had the highest corrosion rate in the presence of salt. However, its corrosion rate was less than the corrosion rate of both galvanized A and galvanized B rebars in pure calcium hydroxide solution. Its corrosion rate increased in the presence of salt. Galvanized A rebar performed better than galvanized B rebar in pure calcium hydroxide solution as well as in $\text{Ca}(\text{OH})_2$ plus the threshold amount NaCl. However, in the presence of 3.5% NaCl, galvanized B performed better. The reason may be due to the fact that galvanized B was coated after it was bent, while galvanized A was bent after it was coated. Secondly, galvanized A rebar was bent by the supplier with a bent diameter more stringent than the other rebars included in this project (Figures 2.7 and 2.8). This means that there is a greater chance of damage to galvanized A rebar.
